AM571x (SR 2.0, 1.0) and AM570x (SR 2.1, 2.0) Sitara™ Processors

Errata

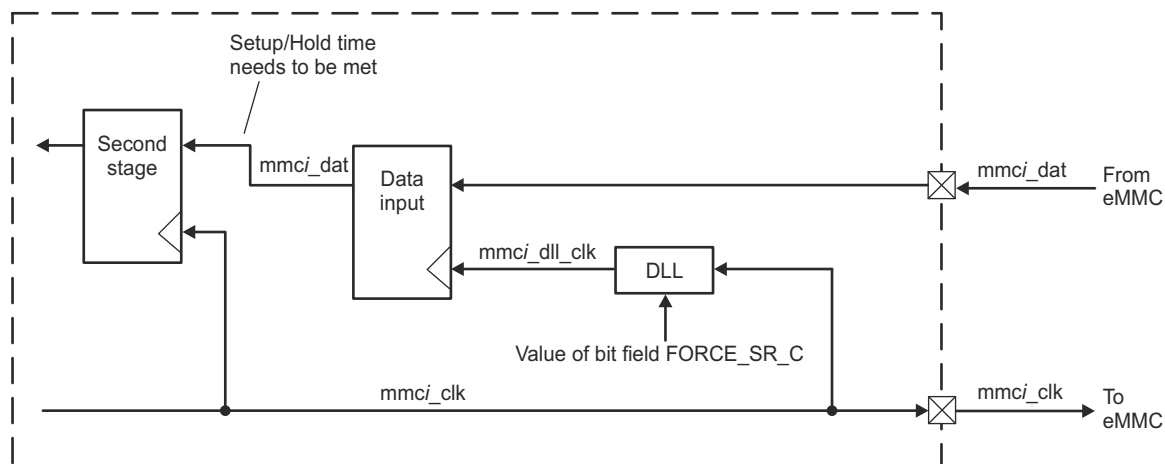
Figure 2-1. Simplified SoC 192-MHz Mode DLL Block Diagram

Internal to the MMC module, a second stage latch is used to recapture data captured by DLL delayed clock, `mmci_dll_clk`. The second stage latch captures with the original transmitting clock, `mmci_clk`.

`mmci_dll_clk` and `mmci_clk` both run at the same clock frequency. This results in a narrow range of tuning ratio elements, where the delayed `mmci_dll_clk` comes in phase with `mmci_clk`. If the clocks are in phase, the data captured by the first clock violates the setup and hold time requirements needed for the second stage latch, resulting in incorrectly read data. This is known as tuning re-timing errors.

A DLL tuning algorithm has been implemented that can avoid the tuning re-timing errors. More details on this can be found in App Note [SPRACA9](#). The following notes summarize the updated algorithm:

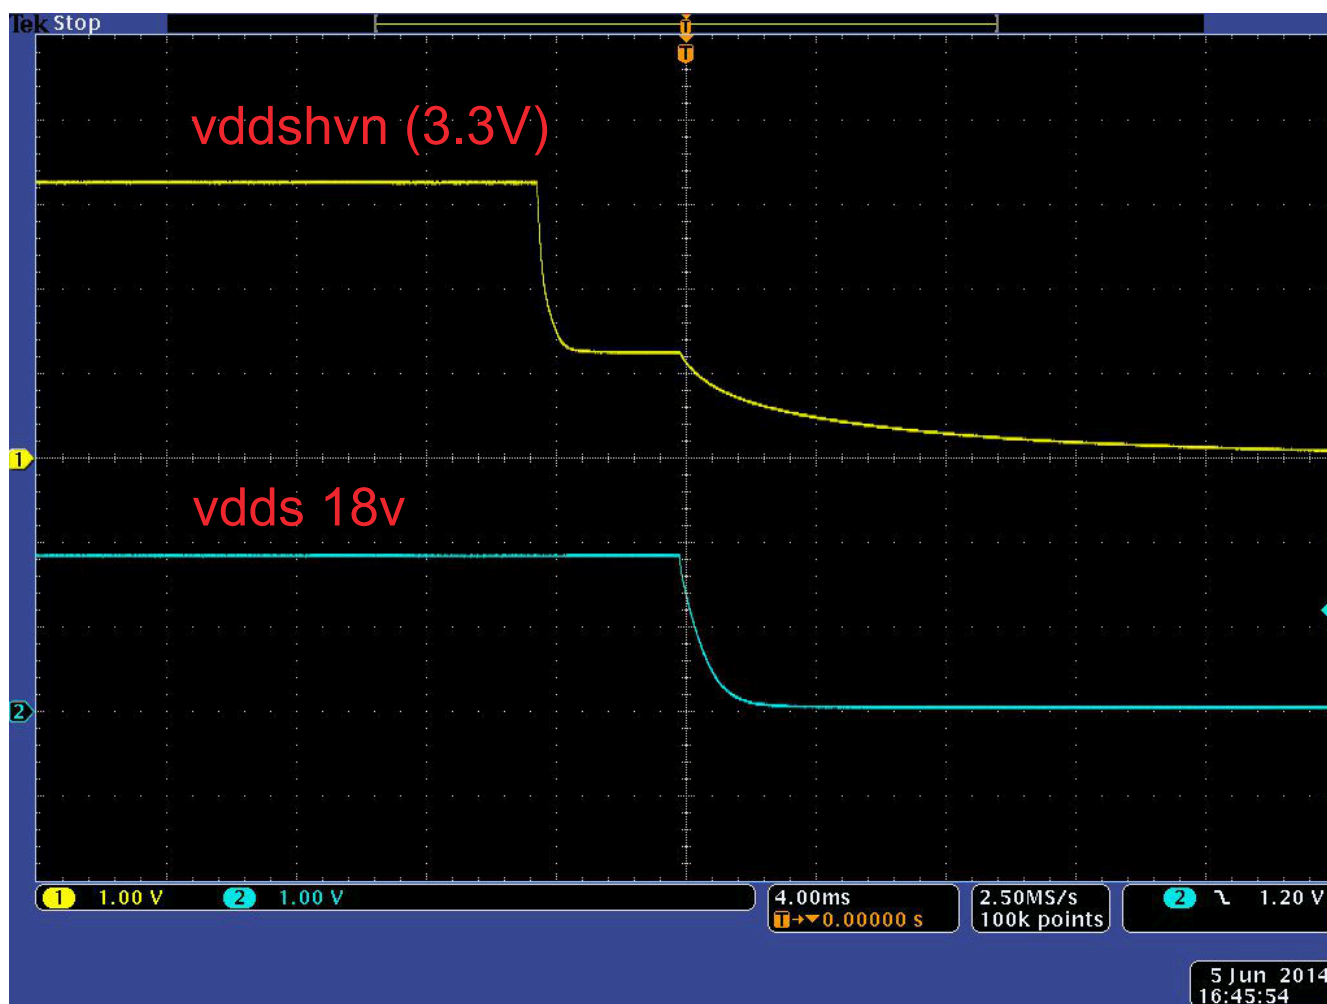
Figure 4-1. PAB_RevA

The Data Manual allows the vddshvn rail (in either 3.3V or 1.8V mode) to power down at the same time or before the vdds18v rail. When the vddshvn rail is powered down before the vdds18v rail, the vddshvn rail stays at Plateau Level (<1.5V) until the vdds18v rail is disabled, as shown in the waveform below.

A subset of the SOC's LVCMOS IOs (refer to DM for details) have a pull-up resistor that is active by default, including during reset and power-down. The SOC's IOs that have internal or external pull-ups will stay at Plateau Level (<1.5V) during the power-down. If other ICs on the board that are interfaced to the SOC's LVCMOS signals use a separate supply then it's possible that the other IC's signals can be pulled to the Plateau Level while its power supply is off.

The root cause of the plateau is related to the LVCMOS IO buffer Dual Voltage detection circuitry. The LVCMOS Dual Voltage IO includes voltage comparator circuitry to determine if the IO is in 3.3V mode or 1.8V mode. During powerdown of vddshvn domains, a current path in the internal bias transistors results in the vddshvn rail being held to an

In general, TI recommends using the same supply source for connected components. E.g., a single LDO should drive vddshvn and the related 3.3V external components.

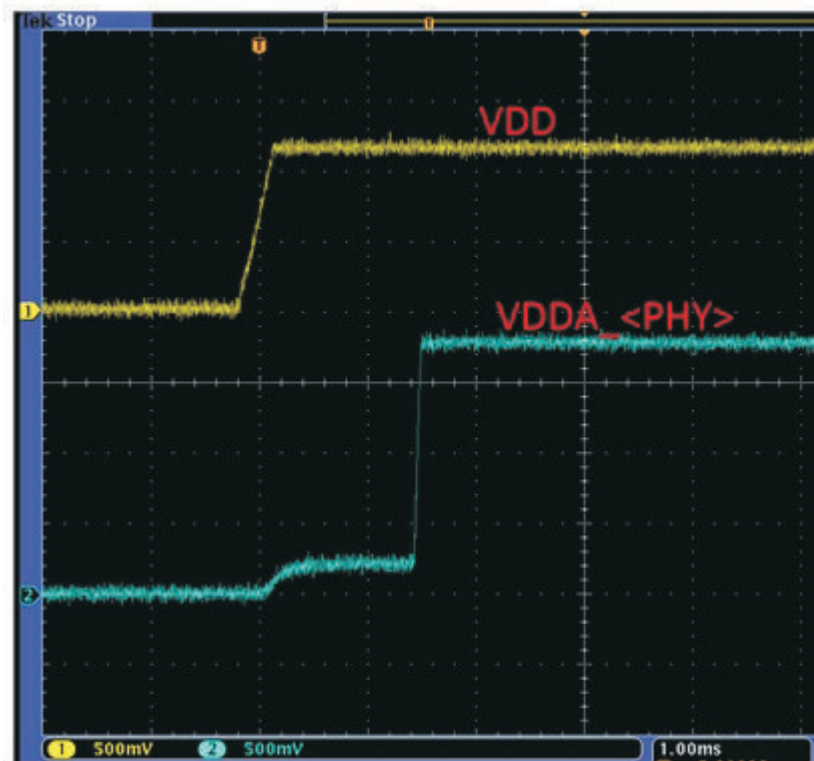
Figure 4-2. Leakage Voltage

The device-specific Data Manual requires Core AVS rail (VDD) to power up before the 1.8 V high speed analog PHY domain(s). When this sequence is followed, the high speed analog PHY domain will have a small step-up to a voltage plateau (< 0.5 V) that aligns to the beginning of the VDD ramp-up, and is maintained until the ramp-up of high speed analog PHY rail, as shown in Figure 4-2. Note the leakage value will differ from system to system, but will be less than 500 mV. The leakage voltage in the provided capture is approximately 250 mV.

A similar condition exist during supply power down sequence. The high speed analog PHY domain(s) are required to be powered down prior to Core AVS rail (VDD), and may cause a small plateau to exist until Core AVS rail (VDD) is ramped down.

The root cause of the voltage plateau during power-up/down sequencing is related to the parasitic diodes in logic blocks which have multiple power sources. This leakage path is not a reliability concern for this device.

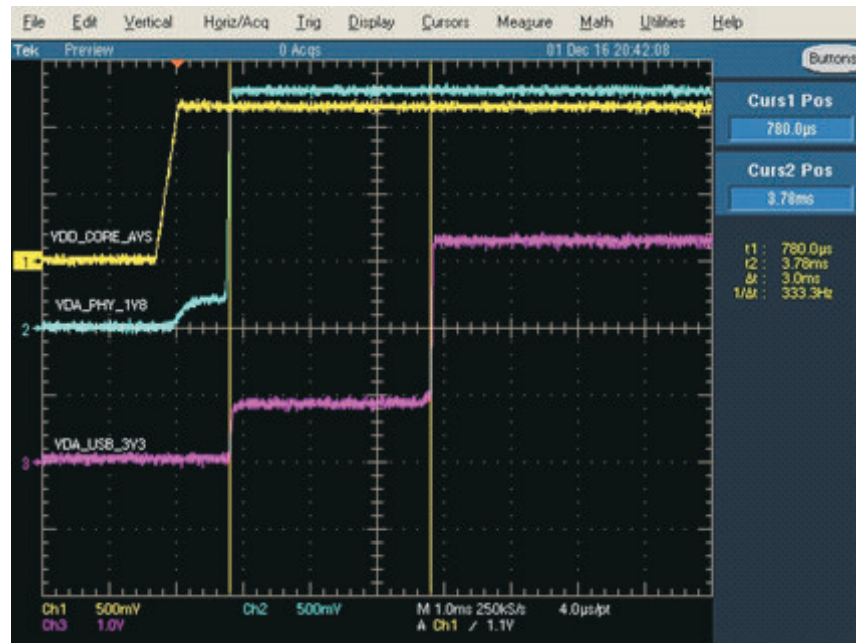
Figure 4-3. Original Power-Up Sequence

An unintended leakage current path between VDDA_PCIE (1.8 V) and VDDA33V_USB1 (3.3 V) due to ESD protection diode connection across the signal to I/O supply pads exists. This path can allow current to flow from VDDA_PCIE to VDDA33V_USB1. The current flows whenever the voltage level on VDDA_PCIE exceeds VDDA33V_USB by more than a diode drop during certain power-up and power-down sequences.

This leakage current causes the un-energized VDDA33V_USB1 to rise to a ~1 V plateau (see Figure 4-3) due to the power resource's "off impedance" seen between the VDDA33V_USB1 power rail to ground. When the minimum "off impedance" is $\geq 100 \Omega$, the SoC leakage current is small and sustainable with no SoC reliability impacts.

Note: Figure 4-3 shows in VDA_PHY_1V8 rail a plateau approximately 250 mV documented in i931, VDD to VDDA_"PHY" Current Path.

TI recommended Power Delivery Networks (PDNs) could have multiple different PMIC LDO power resources connected to the VDDA33V_USB1 rail. The LP87332D/LP873220 PMICs have a minimum OFF resistance equal to 150 Ω so a PDN using these PMICs would not exceed safe leakage current level and could continue to use the original SoC power sequences. However, the TPS65916 PMICs have a minimum OFF resistance equal to 30 Ω and would exceed the safe leakage current limit. As a result, any PDN using TPS65916 PMICs must implement the power sequencing as shown in DM version C or later. The specific sequence changes are:
